## **Tree survey to BS5837:2012 at xxxx**

**Dr. Richard Wilson**, PhD, Tech. Cert. (RFS), Prof. Dip. Arb (RFS), M. Arbor A., Associate member of the Institute of Chartered Foresters

**Client:** xxxx

**Instruction:** The instruction was received from xxxx. The initial enquiry was received by e-mail on July 25<sup>th</sup>, 2017 with an instruction to proceed received on July 26<sup>th</sup>. Inspection took place on August 4<sup>th</sup>, 2017. A survey of the trees according to BS5837:2012 for construction planning is required.

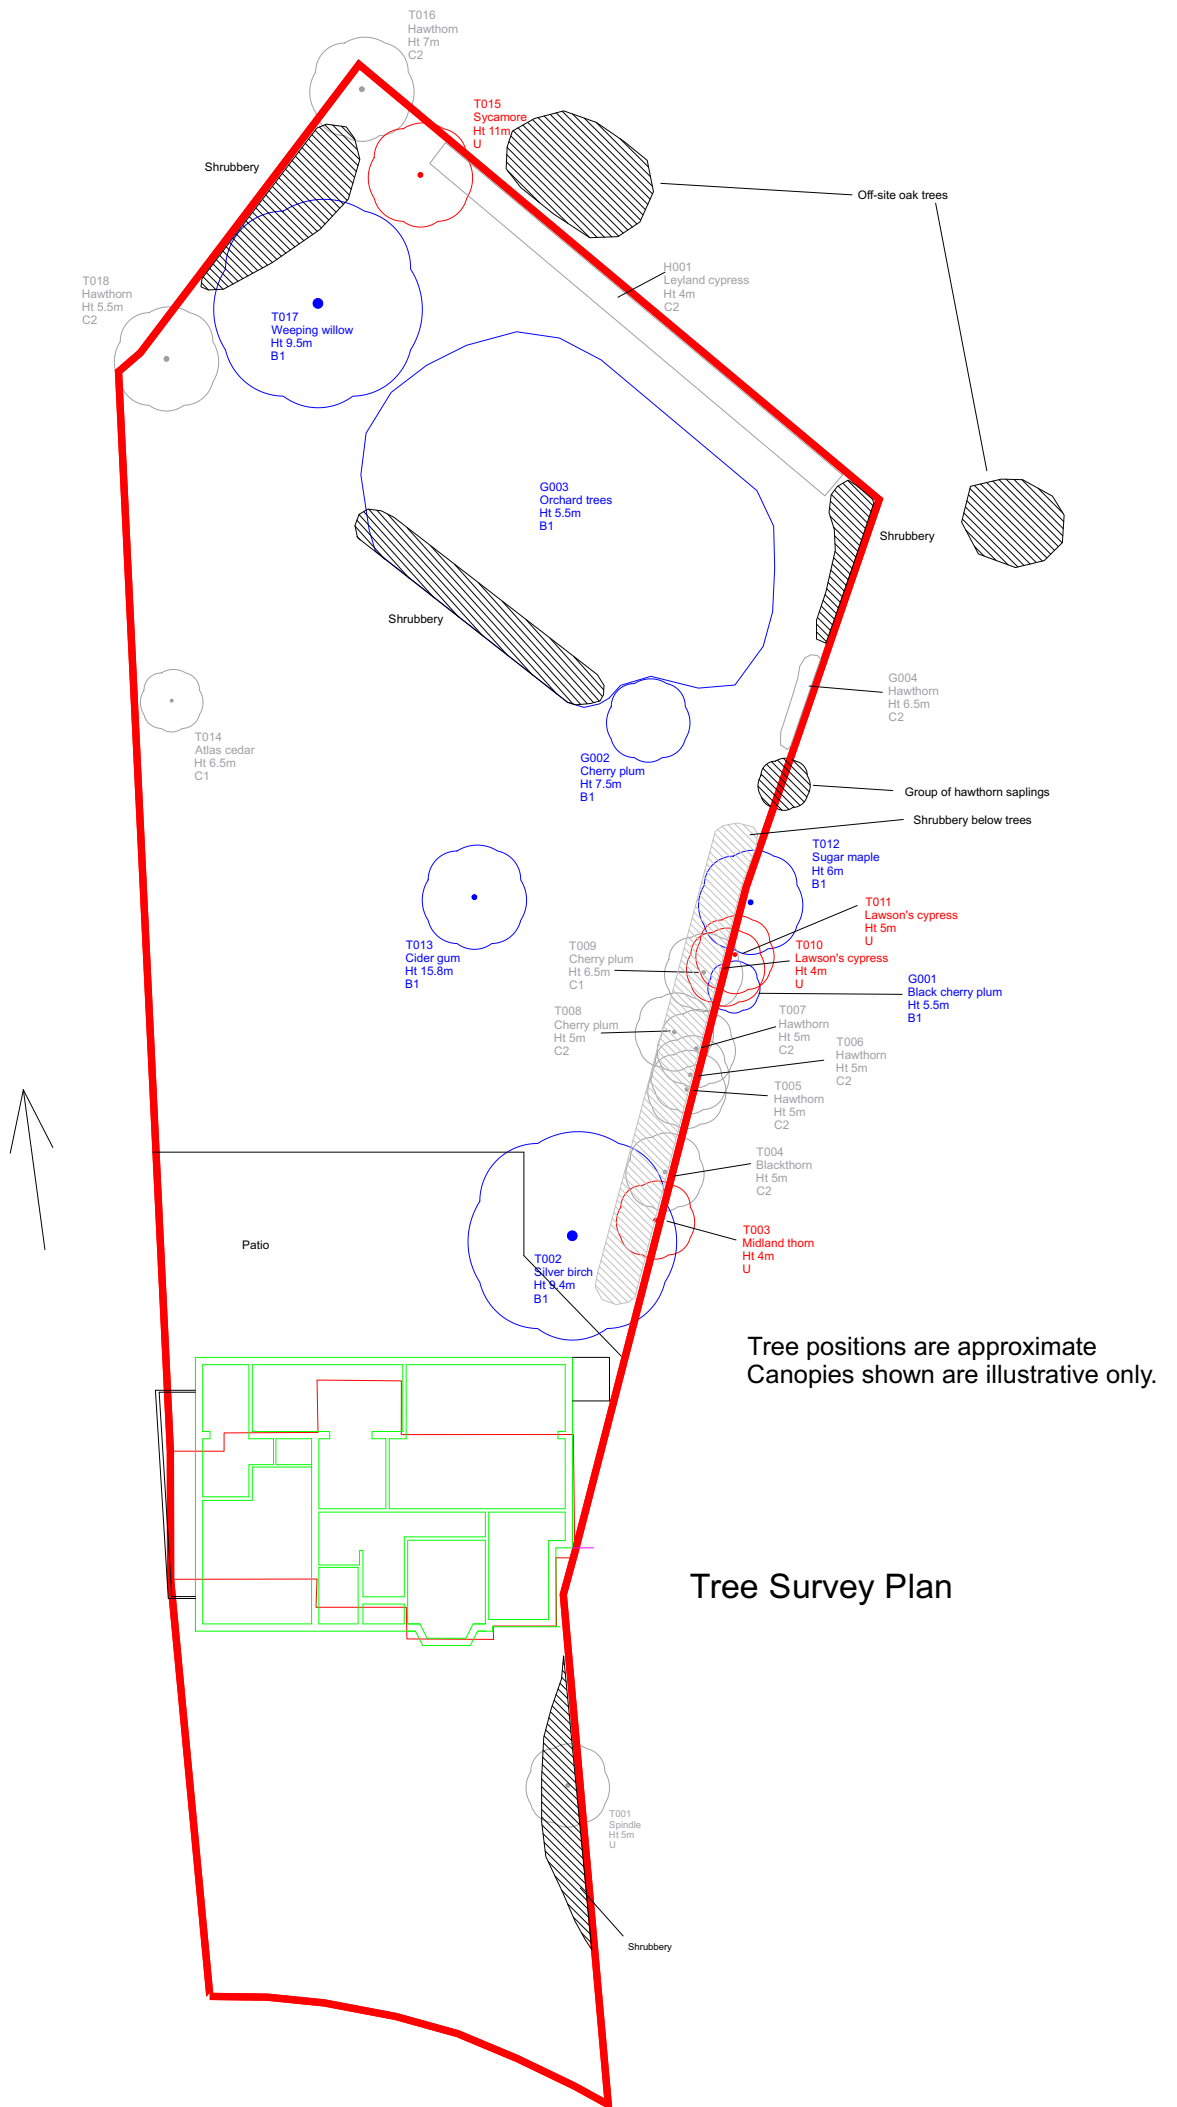
Tree Survey Plan

T003	Midland thorn	4	1	245							2.5	2.5	2	0	0.75 SE	1.5	M	F	relatively under-developed but encroaching heavily on neighbouring garden. Otherwise unremarkable. Pressure on fence unlikely to be tolerated for a significant period.	<10	U	Fell to prevent damage to fence.
T004	Blackthorn	5	1	80							1	2	2	2.5	1 W	1.5	SM	G	Young tree of good form and condition. No significant defects and generally unremarkable although with some value as an ecological food source. Forms hedge together with T005 - 008. Low value.	40+	C2	
T005	Hawthorn	5	1	80							2.5	2	2.5	3	1.5 S	2	SM	G	Young tree of reasonable form and condition. No significant defects and generally unremarkable although with some value as an ecological food source. Forms hedge together with T004 & 006 - 008. Low value.	40+	C2	
T006	Hawthorn	5	1	75							0.5	2	2	2	1.5 W	2	SM	G	Young tree of reasonable form and condition. No significant defects and generally unremarkable although with some value as an ecological food source. Forms hedge together with T004, 005, 007 & 008. Low value.	40+	C2

T011	Lawson's cypress	5	1	80							1	1	0	0	1 N	1	SM	P	Unattractive tree with brown dying foliage and dense variegated ivy cover. Partial inspection only. Likely suppressed by T009. Low value tree.	<10	U	
T012	Sugar maple	6	1	185							3	4	3	3	1.5 N	2.5	EM	G	Attractive off-site tree. No significant defects but lacking special qualities of Cat A.	40+	B1

Ref. No. (T/G/W/H/HR)	Tree Species	Ht (m)	Stem count	1	2	3	4	5	N	E	S	W	Ht. 1st branch	Ht. canopy	Life stage (Y,SM,EM,M,OM,V)	Health (G,F,P,D)	Observations	ERC (<10,10+,20+,40+)	QA Category (A,B,C,U)	Urgent recommendations
T013	Cider gum	15.8	1	295					3	3.5	2	2	4.5 N	4.5	EM	G	Attractive tree of good form and condition and only minor defects. Stem arises with 15° lean to NE but sweeps to upright by 2.5m. Could develop into attractive amenity tree of future. Currently lacking special qualities of Cat A.	40+	B1	
T014	Atlas cedar	6.5	1	130					2	1.5	2	1	0.5 E	0	SM	G	Recently planted tree of good form and condition. No significant defects. Could develop into attractive amenity tree of future. Currently lacking special qualities of Cat A.	40+	C1	
T015	Sycamore	11	1	370					2	2	5	4	2 W	3	M	F	Arises as single-stemmed tree and bifurcates at 1.25m - union stable and non-included. Crown asymmetrical but healthy and full. Basal decay extending into root plate and extending upwards into stem. Rail line behind fence but crown weighted in opposite direction with off-site oak tree behind.	<10	U	Fell tree within 4 weeks.

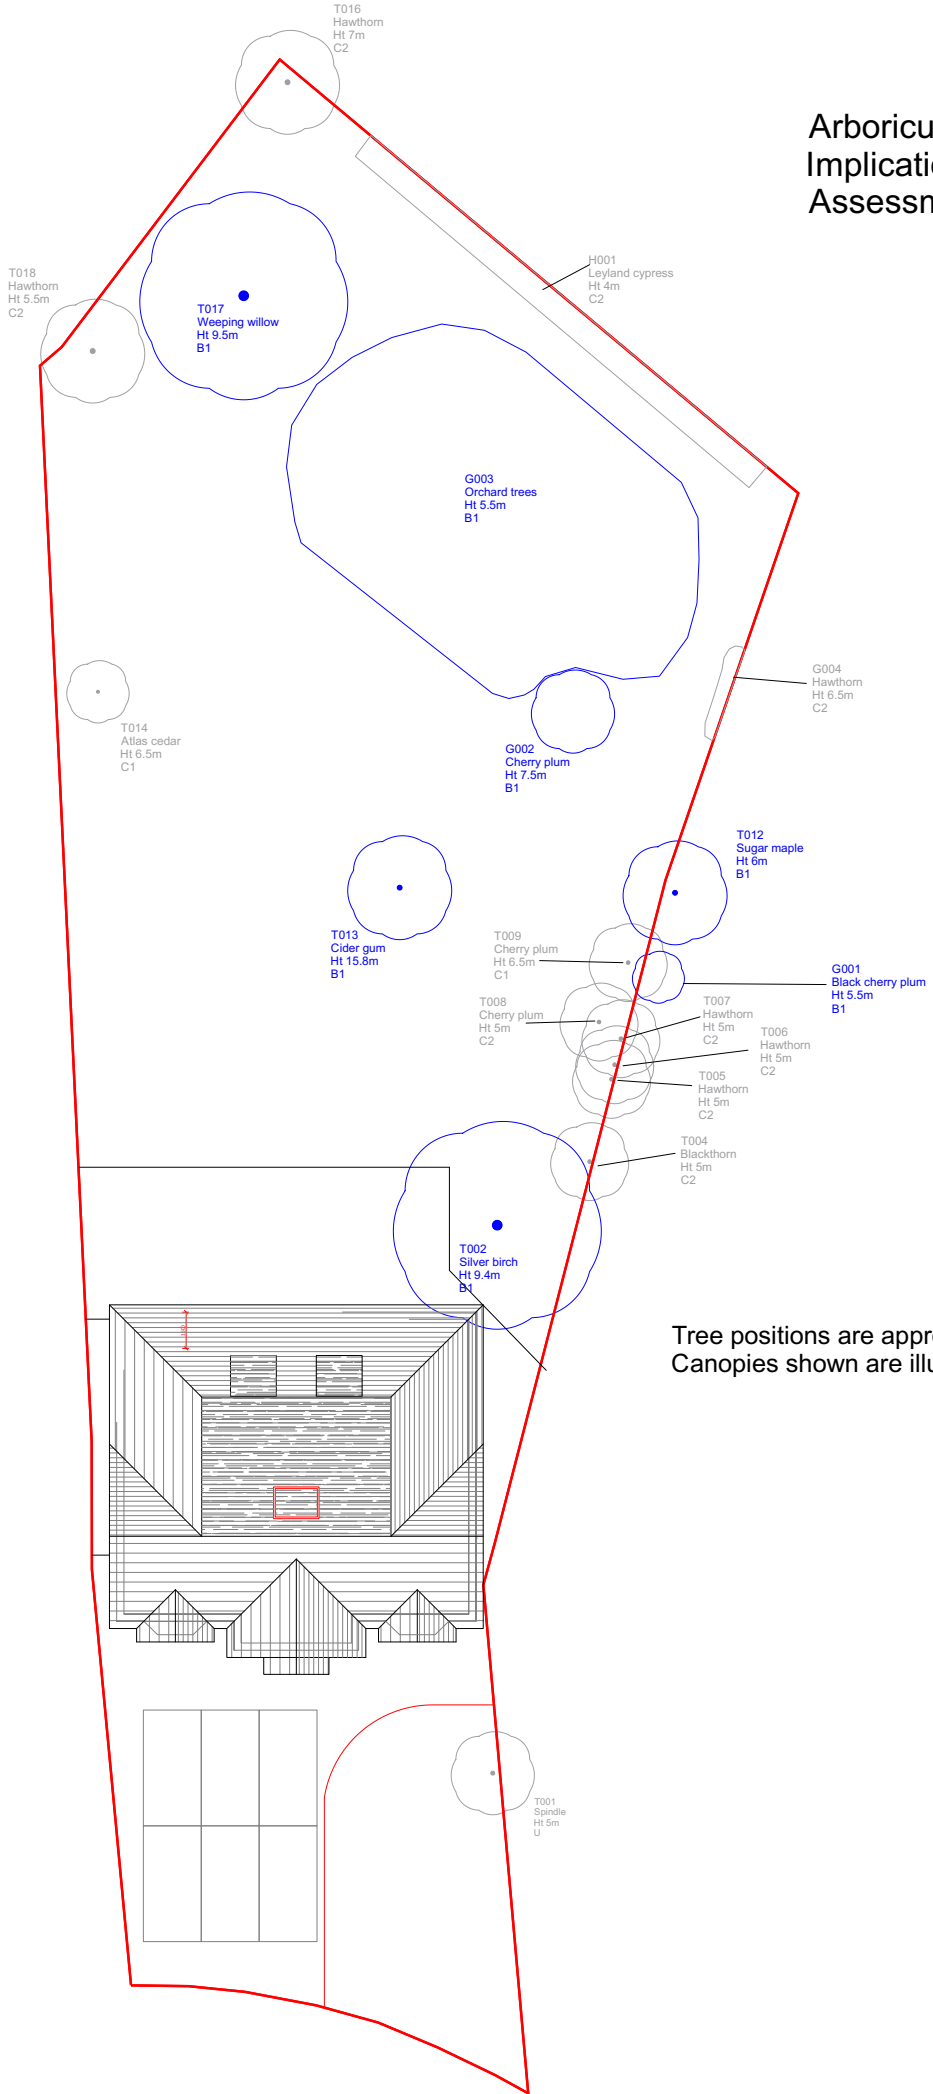
# Arboricultural Implications Assessment

- The site is currently affected by a total of 18 individual trees, 4 tree groups containing approximately 18 trees and one domestic hedge.
- Trees to remove:

- The following trees have been assessed as Category 'U' (retention for >10 years not realistic) and should be felled:  
T003, 010, 011 & 015 (4 trees; 11%).  
With the exception of T003 these are sufficiently far from the proposed development to be unaffected by it.

- Trees to retain: all other trees may be retained (89%).
- Trees to the north of T002 are sufficiently far from the proposed development to be unaffected by it and have not been considered further.

- Access facilitation pruning to lift the crown of T002 above the proposed new roof line will be required. This should be carried out sympathetically in late summer by suitably competent arboriculturists.

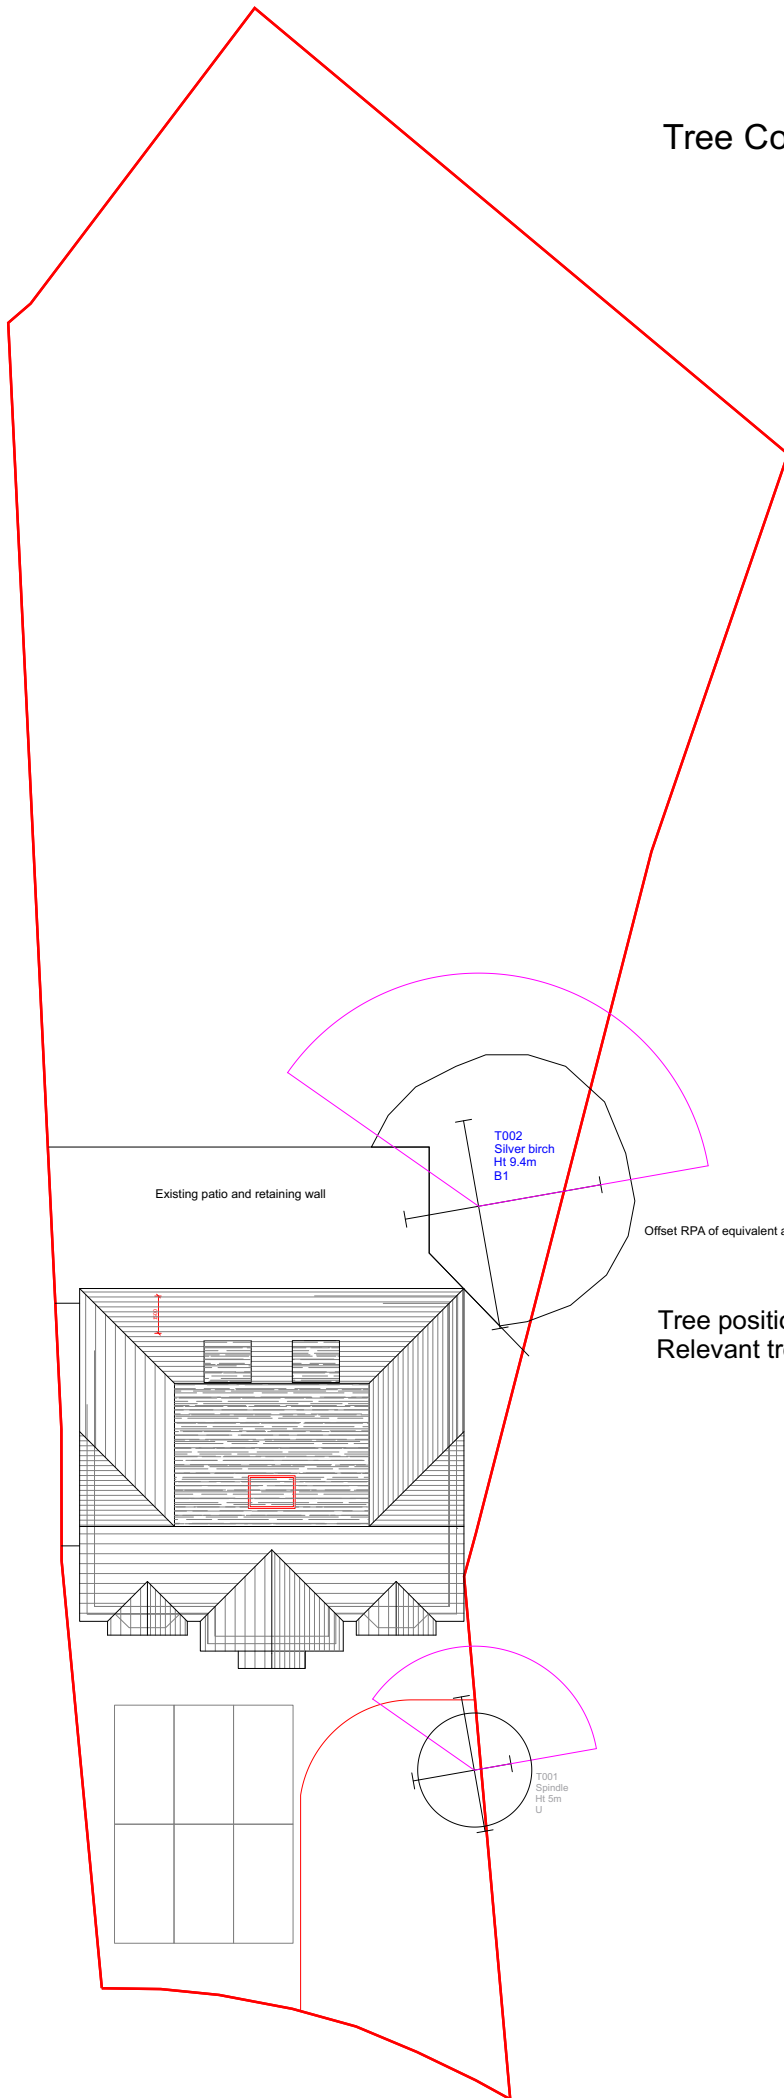
# Tree Constraints Plan

- Root protection areas are indicated on the Tree Constraints Plan in black. Due to the presence of the patio retaining wall, an offset RPA of equivalent area has been drawn for T002.

- Root Protection Area (RPA) encroachment: The proposed development will not result in new permanent encroachment into any RPAs.
- The crown of T002 is expected to overhang the NE corner of the proposed new building and the need for Access Facilitation Pruning has already been noted (above).

- Shade arcs are drawn on the Tree Constraints Plan in magenta. The proposed design would not be subject to unacceptably high levels of shading.
- Retained trees can be expected to create large amounts of leaf litter, seed cast & fallen fruit but these are sufficiently far from the building and hard surfaces so as not to present any particular issues.

- Design & construction constraints.
  - Demolition: Where demolition takes place within 5m of T002 it is to proceed from within the footprint of existing buildings using 'pull-back' techniques.

- Foundations: The presence of a deep London Clay soil raises the possibility that seasonal soil shrinkage may be encountered on this site. Sleeved micropiles of the smallest size suitable for the proposed structure may be required. Where piling takes place within 5m of T002, the piling rig is to stand within footprint of existing building.

- Services for the dwelling should be laid in a single common service trench passing under the proposed driveway and positioned outside RPAs to minimise root damage; soakaways etc. to be positioned outside RPAs.
